Buttressing an Aging Gravity Dam with RCC to Remedy Flood Risk

Michel H. Jubran, Gannett Fleming

Roller-compacted concrete (RCC) was the material of choice to buttress Loch Raven Dam, almost a century old cyclopean concrete structure. The RCC rehabilitation, project initiated in 2002, brought the dam into compliance with current safety requirements and significantly increased its spillway capacity.

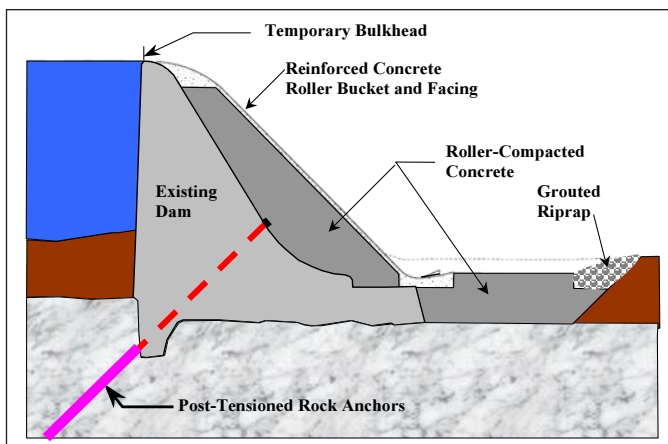
Cross-section of spillway showing proposed modifications.

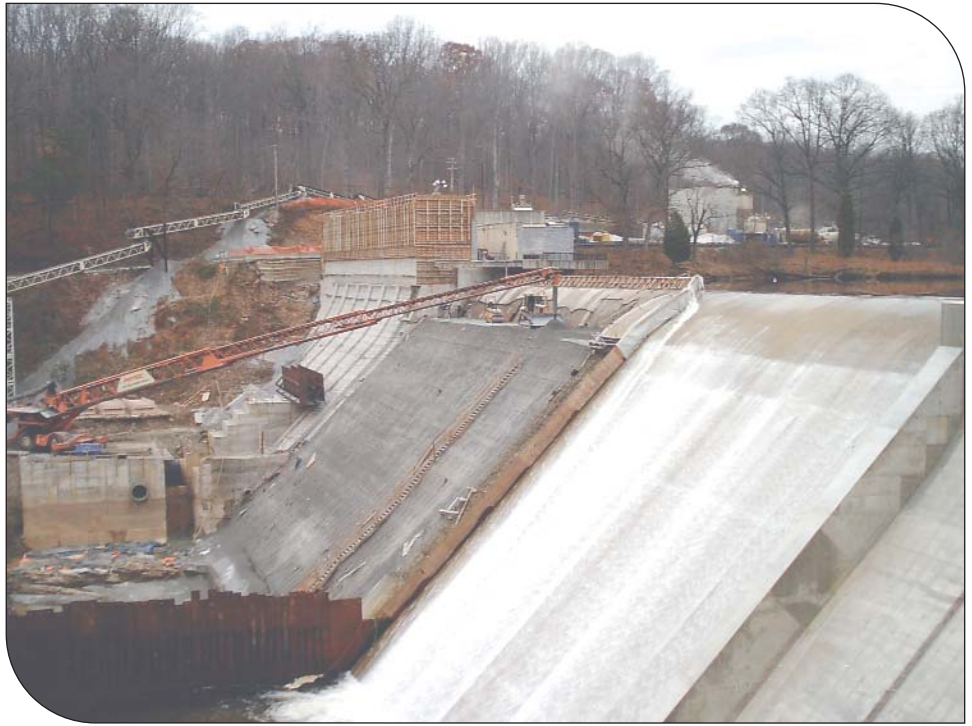
RCC nearing completion on the west section of spillway while the east section is operating. Note the RCC mixing plant and conveyor system in the background.

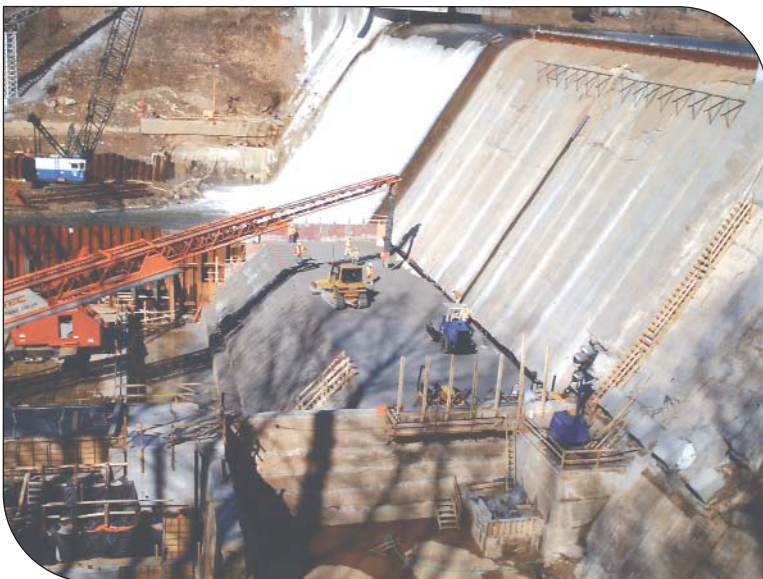
RCC placement on the east section of spillway while the west section is operating.

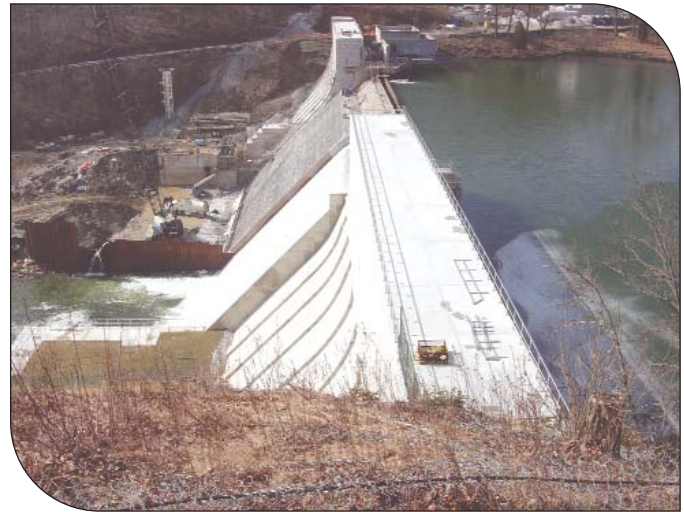
A view of the dam after completion of RCC placement on the west end prior to placing reinforced concrete facing and weir.
