fire protection planning report

BUILDING CONSTRUCTION INFORMATION FROM THE CONCRETE AND MASONRY INDUSTRIES

August 1994

ASSESSING THE CONDITION AND REPAIR ALTERNATIVES OF FIRE-EXPOSED CONCRETE AND MASONRY MEMBERS

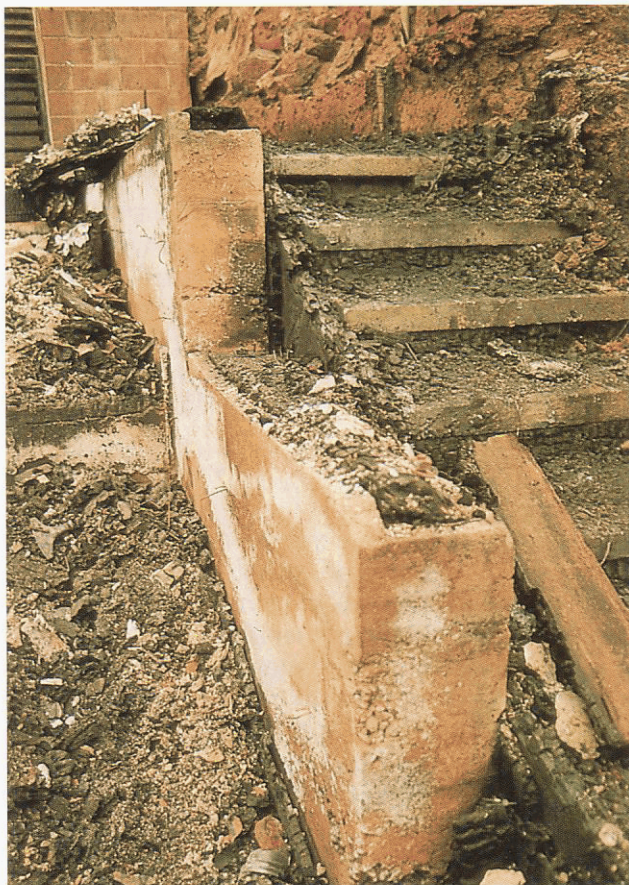
After a building fire, concrete and masonry members may be all that remains. An accurate assessment of the damage is essential to the restoration process.

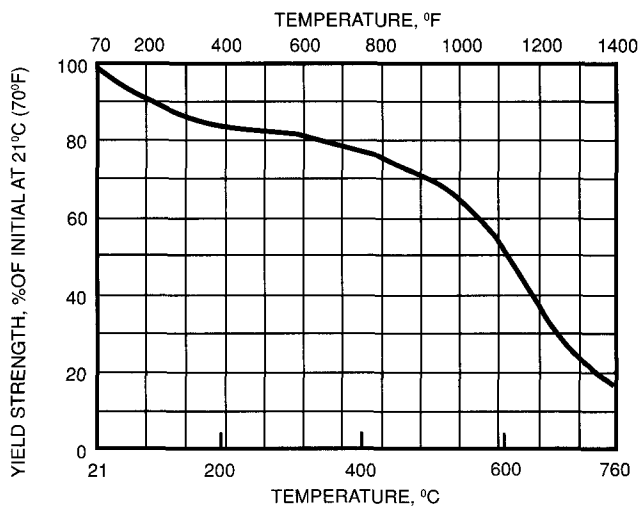
Fig. 1. Yield strength of hot-rolled structural grade steels at elevated temperatures as a percentage of initial yield strength at 21°C (70°F). Source: Ref. 3.

Wood-and steel-framed construction do not offer these advantages. In other than small fires, wood framing members are often consumed as fuel, leaving demolition and reconstruction as the only viable alternative. Unprotected structural steel suffers equally destructive consequences. Lightweight steel trusses and bar joists can collapse after just 5-10 minutes of fire exposure.⁽¹⁾ Steel columns of small cross-sectional area typically possess a fire endurance of no more than 10-20 minutes.⁽²⁾ Although steel regains strength upon cooling, the amount of recovery is dependent upon the maximum temperature reached within the material. Members that are severely distorted during a fire will cool in the deformed position making strength gain useless. The result is irreparable damage to the steel. Fig. 1 shows the yield strength of steel at elevated temperatures as a percentage of the yield strength at 21°C (70°F).

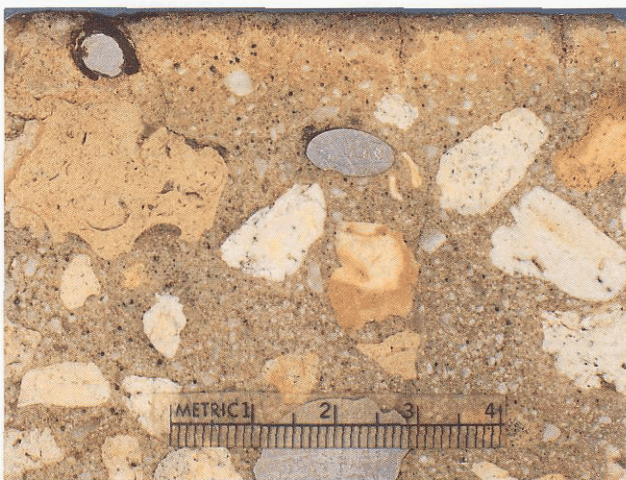
Note the presence of cracks in the region of pink discoloration. Also observe the partial change of aggregate color (upper right) from yellow gold to red.

The observation of a pink discoloration to a given depth of concrete (see photo) indicates that minimum temperatures of 300°C (572°F) have occurred. This discoloration is accompanied by a significant loss of concrete strength within the discolored region. Sometimes the discoloration can be seen without the need of extracting cores, such as in areas of spalled concrete. If this phenomenon has occurred, it can be used as a tool in determining the likelihood of damage

to non-prestressed reinforcing steel (bars). Where the depth of pink concrete is less than the cover thickness, the reinforcing steel is not likely to be seriously affected by temperature. If the pink discoloration extends all the way to the reinforcement, further investigation of the steel's strength, and the concrete's strength beyond the depth of reinforcement is necessary. Concrete in the region of discoloration must be removed prior to making repairs.

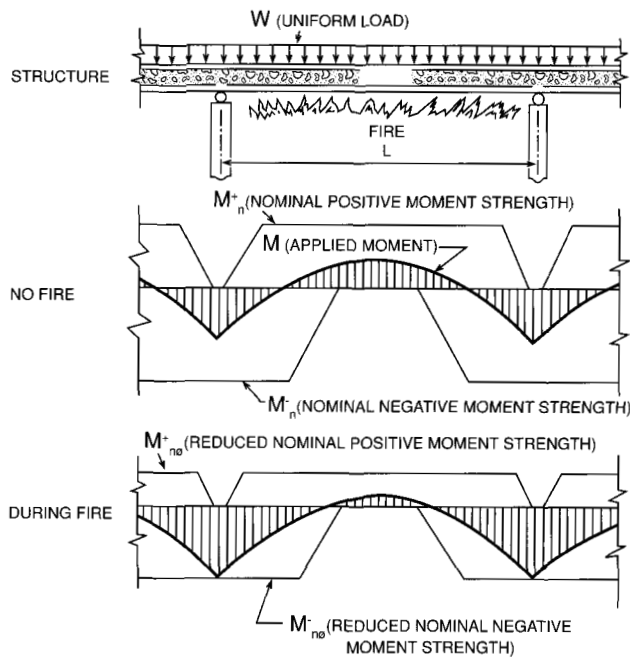
Fig. 2. Moment diagram for a symmetrical interior span of a continuous one-way slab or beam before and during fire exposure—neglecting axial restraint due to thermal expansion.

In continuous beams and slabs, it is not unusual to observe flexural cracking in the negative moment region (over the supports). This behavior can be explained by Fig. 2. Assuming that a sufficiently severe fire exists, a redistribution of moments takes place early in the fire exposure period. Redistributed moments are generally limited by the nominal negative moment strength near the supports and have the effect of significantly reducing the applied positive moment. In an ASTM E119 fire test, yielding of the negative moment reinforcement (Fig. 2c) typically occurs within the first 30 minutes. At some point from the beginning of the fire exposure to the time of yielding, the cracking moment strength in the negative moment regions is reached and cracks develop. As the

duration of the fire exposure increases, the nominal positive moment strength is influenced by elevated temperatures and continues to diminish. If it decreases to the point where it becomes equal to the applied (redistributed) positive moment, a third hinge forms and collapse occurs.

Since cracking in the negative moment regions occurs well before significant reductions in the nominal positive moment strength, the severity of the damage due to cracking cannot be readily determined from a visual inspection of the member. This is why it is beneficial to be able to estimate the intensity and duration of the fire in comparison to the standard E119 fire condition. Conversely, if no cracks are visible in the negative moment regions, the fire was not sufficiently severe to cause the concrete's cracking moment strength to be reached. In this case, the strength of the steel reinforcement can be considered to be unaffected. A detailed investigation of these regions may become necessary if the precise value of the residual yield strength of the steel must be known for subsequent structural evaluations.

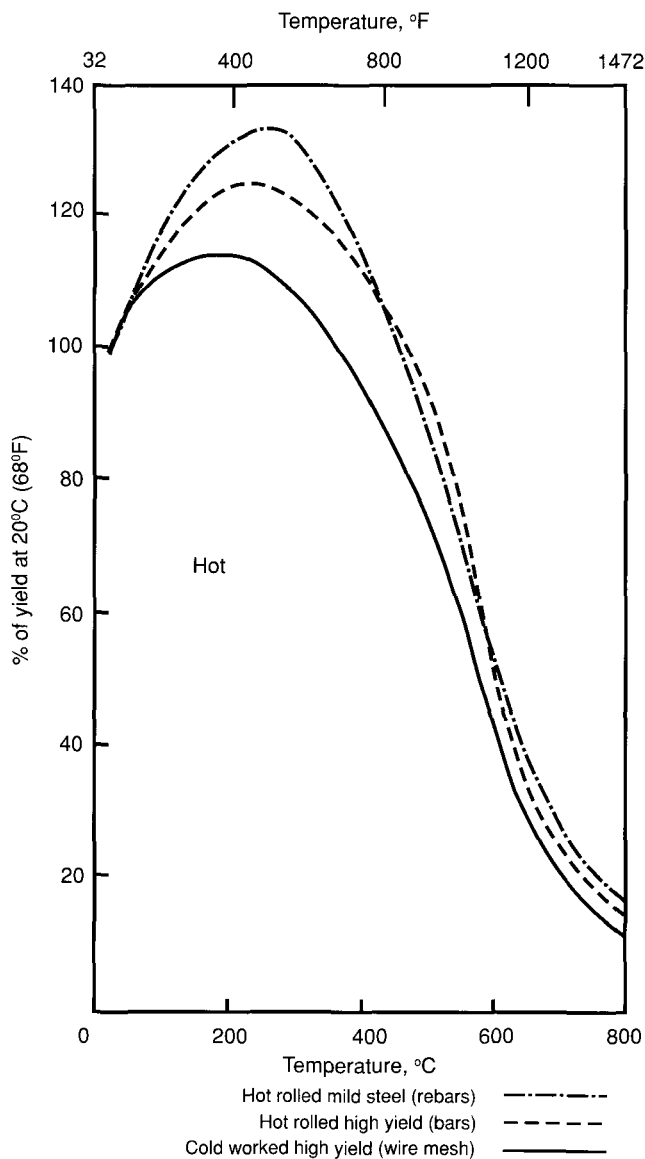
Fig. 4a. Yield strength of steel reinforcement while hot.

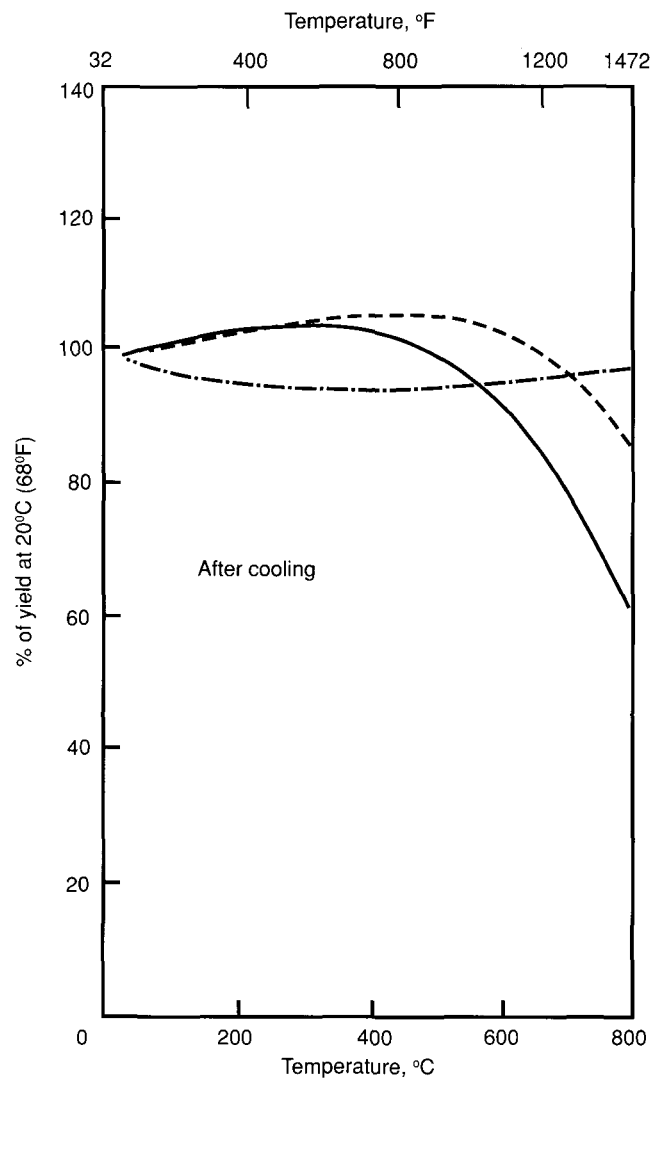
Fig. 4b. Yield strength of steel reinforcement after cooling.

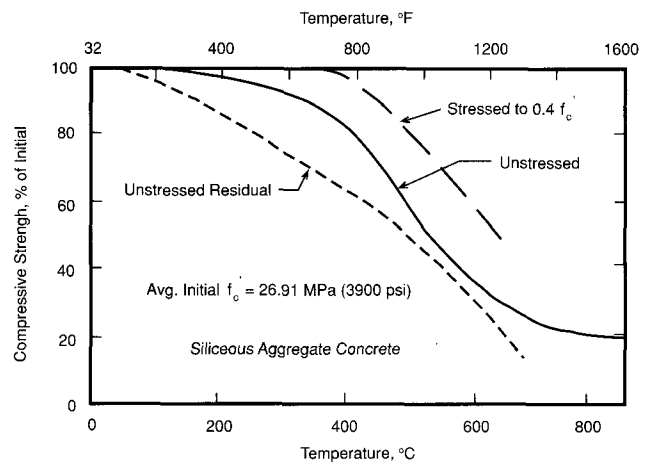
Fig. 3a. Compressive strength of siliceous aggregate concrete at high temperatures and after cooling.

Temperature gradient is of particular interest in fire-exposed columns, because once known, strength-temperature relationships shown in Figs. 3a-3c can be used to estimate the post-fire residual compressive strength of the concrete. Using the "unstressed residual" curves leads to conservative residual strength estimates. The other curves in the figures may be used with sufficient expertise and sound engineering judgment. Pre-fire load conditions of columns, the redistribution of loads to surrounding construction, and stress reduction due to strength loss of columns at elevated temperatures are factors that can influence the decision in using an alternate curve. All of the curves assume that there is no significant internal cracking of the concrete.

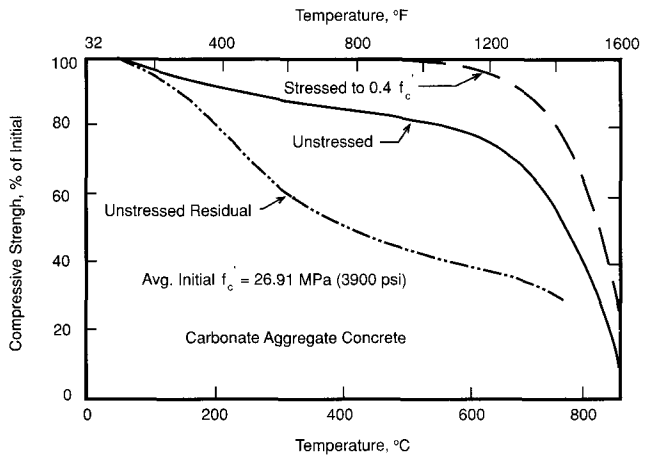
Fig. 3b. Compressive strength of carbonate aggregate concrete at high temperature and after cooling.

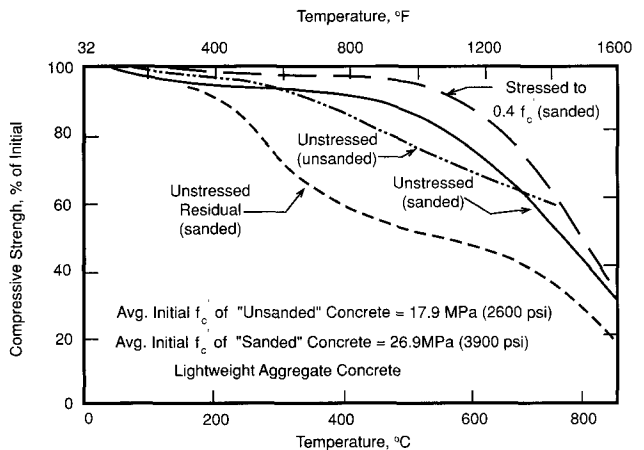
Fig 3c. Compressive strength of lightweight aggregate concrete at high temperature and after cooling.

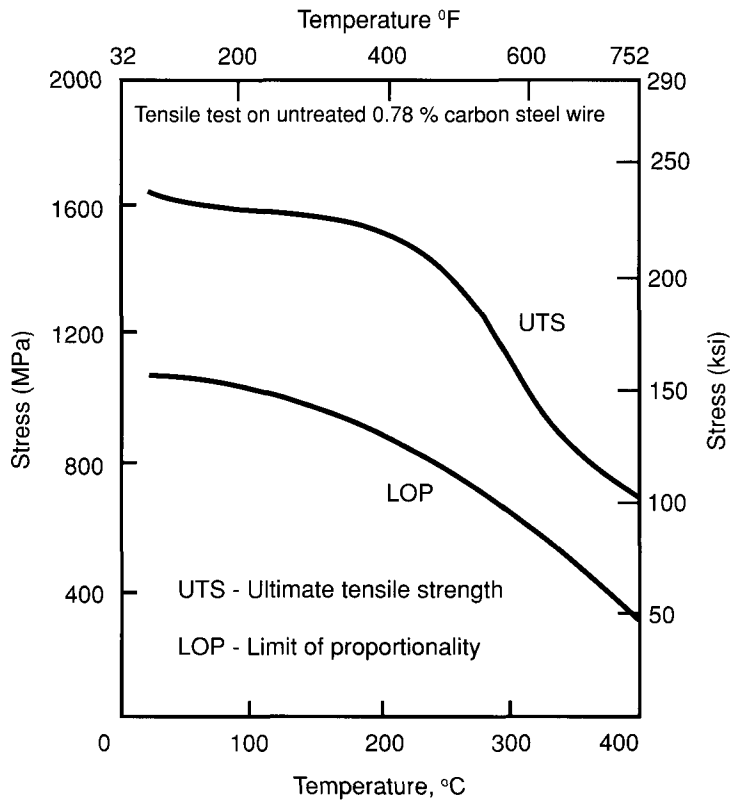
Fig. 5a. Temperature effects on untreated cold drawn prestressing wire. (left)

The effect of temperature on prestressing steel is more complex. In conjunction with the strength loss associated with the limit of proportionality (LOP) decreasing with temperature, permanent relaxation losses in the steel can occur well after the exposure to fire has ended. As the elevated temperatures reduce the LOP to a value less than the initial prestress of the strand (at ambient conditions), the prestress is similarly reduced. Relaxation losses in the steel based on the maximum temperature and duration of exposure, further contribute to a reduction in prestress. This effect is illustrated in Figs. 5a-5e. These relaxation losses are not recovered upon cooling.

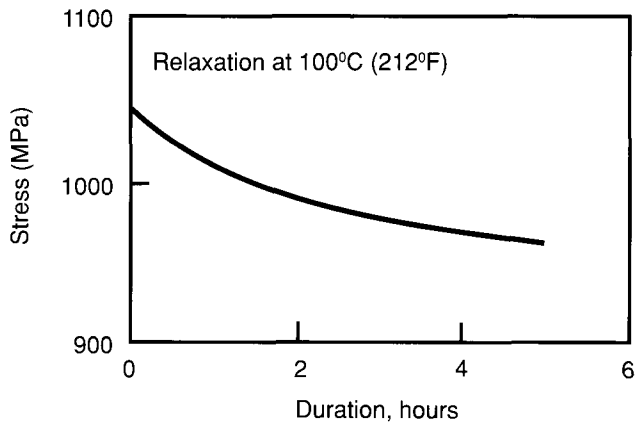
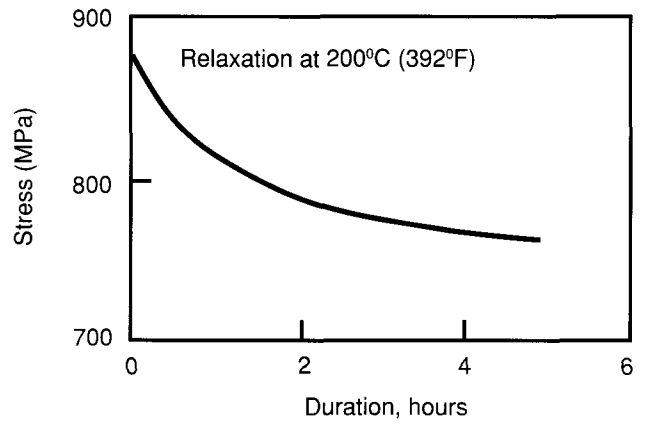
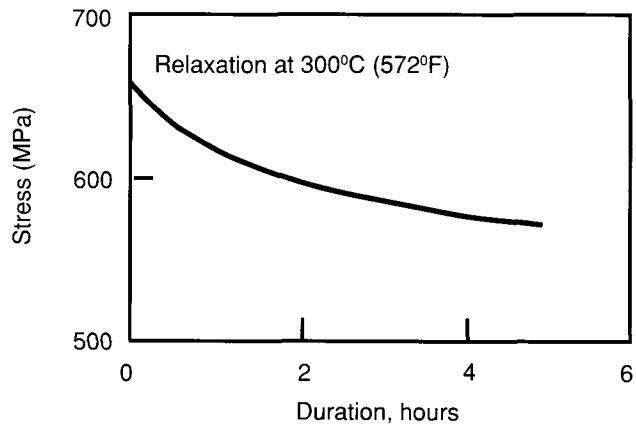
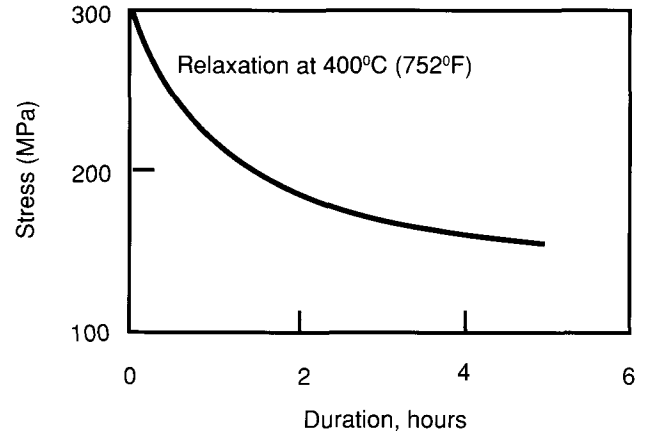
Fig. 5b - 5e. Extended temperature effects on untreated cold drawn prestressing wire. (below)
