**Field Investigation: Pre-Cracking of Soil-Cement Bases to  
Reduce Reflection Cracking**

Paper Submitted for Presentation and Publication  
In the 2002 Annual Meeting of  
Transportation Research Board  
Washington, D.C.

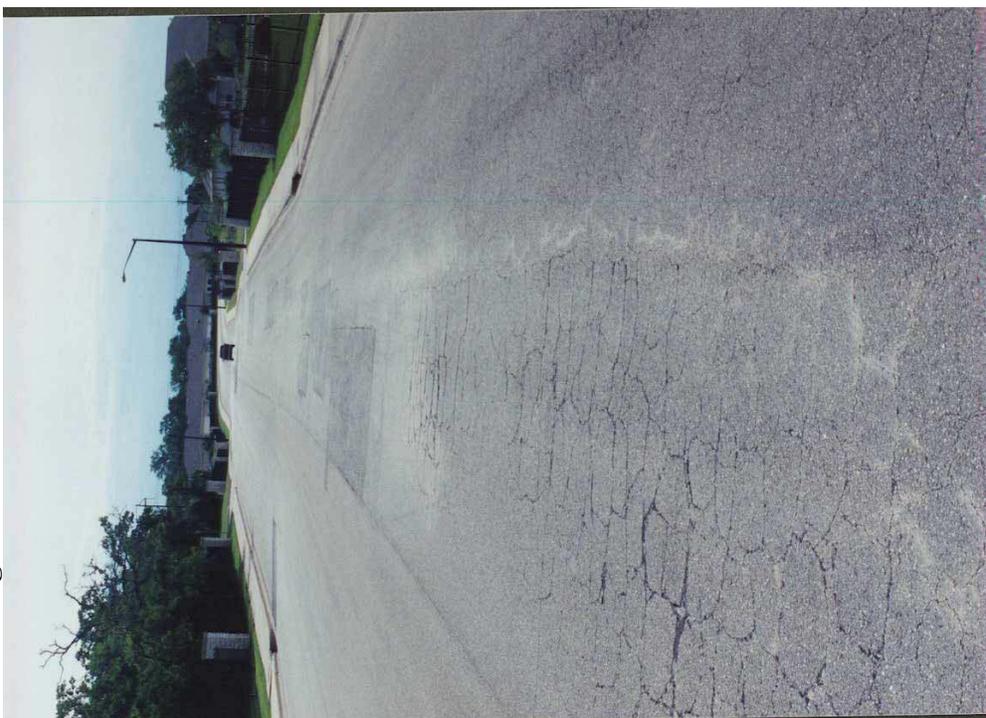
**a) Flexible Base Section**  
**(Moisture often enter base material via leaking construction joint. Lack of an effective seal over the base can accelerate deterioration. Sprinkler systems are also a concern.)**

In Figure 1 the flexible base section is exhibiting structural base failure caused by moisture entering the base, severely reducing its load bearing capacity. This moisture can enter the base through the surface defects or the longitudinal construction joints. Deterioration is accelerated if the top of the base is not adequately sealed. Rain is a concern but perhaps a bigger problem is the numerous sprinkler systems found in this residential area.

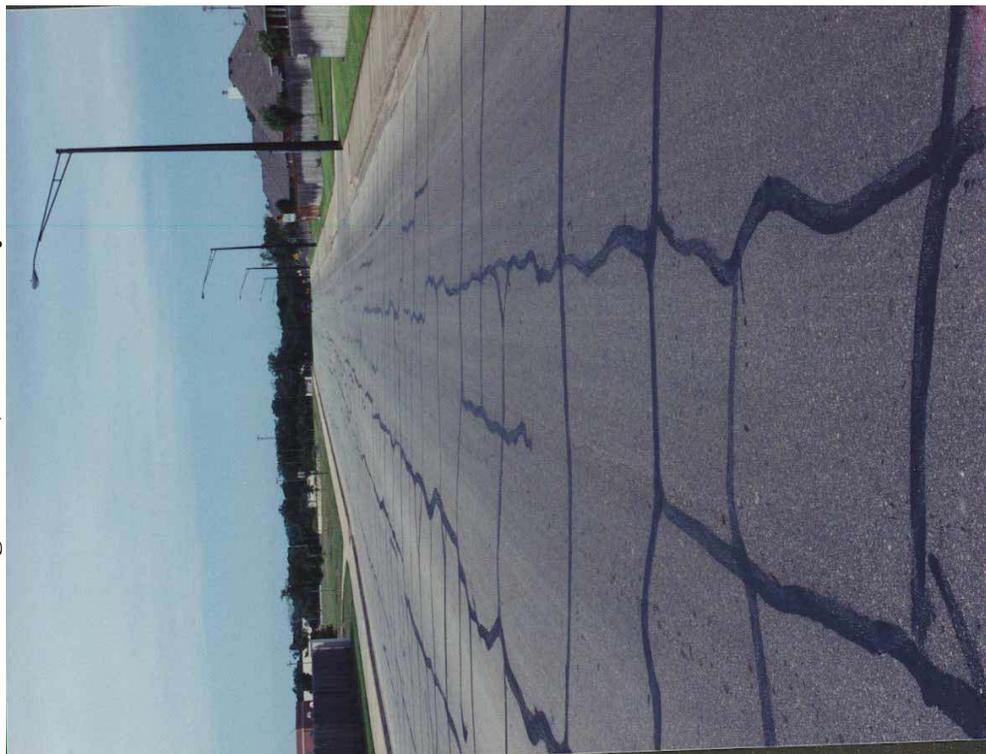
**b) Soil-Cement Section**  
**(Excessive shrinkage of the stabilized base results in block cracking. This is initially cosmetic but can lead to secondary structural problems and loss of riding quality)**

The soil-cement section in Figure 1 is showing a different distress pattern. The block crack pattern is normally associated with shrinkage of the base layer. This cracking occurs early in the life of the base and reflects through the HMA surface. The causes and cures of shrinkage cracking will be discussed later. Initially this is a cosmetic problem, but if the cracks are wide and moisture enters the lower layers then structural damage can occur. Wide cracks also can significantly impact the riding quality of the finished surface. The advantage of soil-cement bases is that they are not usually moisture susceptible and therefore the alligator cracking problems shown in the flexible section will not occur. However excessive shrinkage cracking early in the pavements life is also unacceptable, it is a concern to both city officials and street developers. In the summer of 2000 the early cracking in several newly constructed streets caused the City of College Station to consider mandating the use of only flexible base in future construction. The study described in this paper was initiated to attempt to mitigate these early shrinkage-cracking problems.

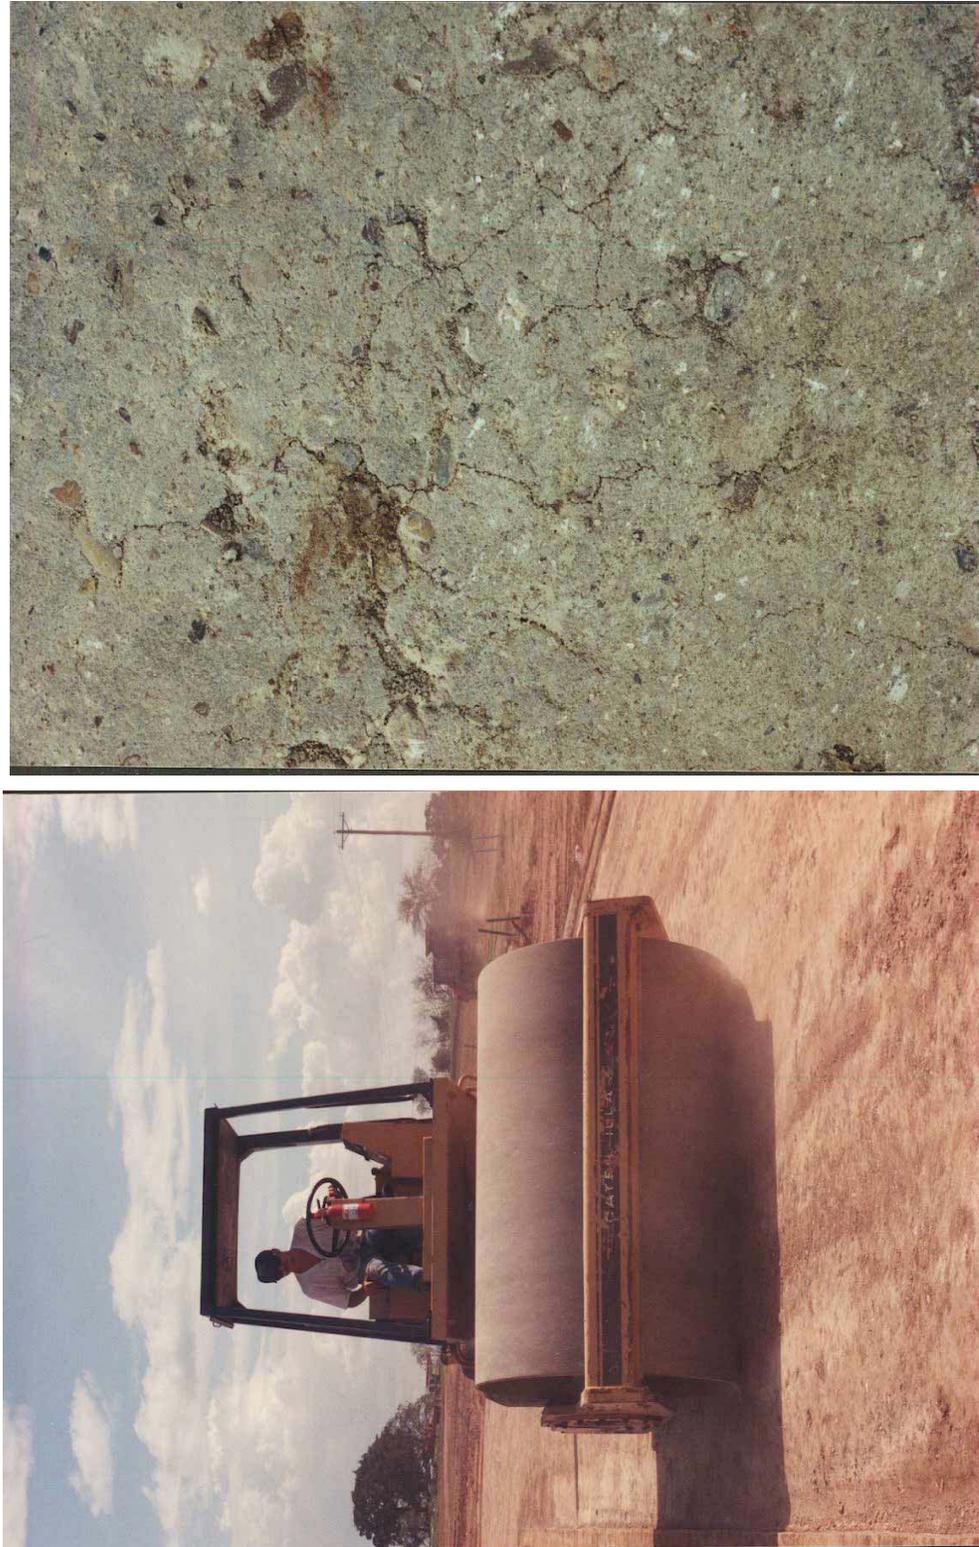
**Figure 2. Microcracking of Soil-Cementin Edelweiss subdivision, Oct 2000.**

- **Introduces a network of microcracks into base to avoid major shrinkage cracks.**
- **First proposed in Austria in early 1990's**
- **Heavy Steel wheel vibratory roller applied to base 1-2 days after compaction followed by 2 days moist cure.**

Three sections, Salzburg Court, Von Trapp and Newburg Court, were constructed in October 2000. The pavement structure consists of 6 inches of lime-stabilized subgrade, 6 inches of soil-cement and a 2-inch HMA surfacing. This was a wet period of the year, which delayed several phases of the construction. The first section on Salzburg was placed shortly after substantial rainfall. This section was cured for 24 hour, then pre-cracked as shown in Figure 2. A heavy 12-ton steel wheel roller was used, operating at a slow walking speed around 2 mph, with the vibrator set to maximum amplitude. It was difficult to see the impact of the rolling, but in a few locations it was possible to see a web of surface cracks. A typical example is shown in Figure 2.

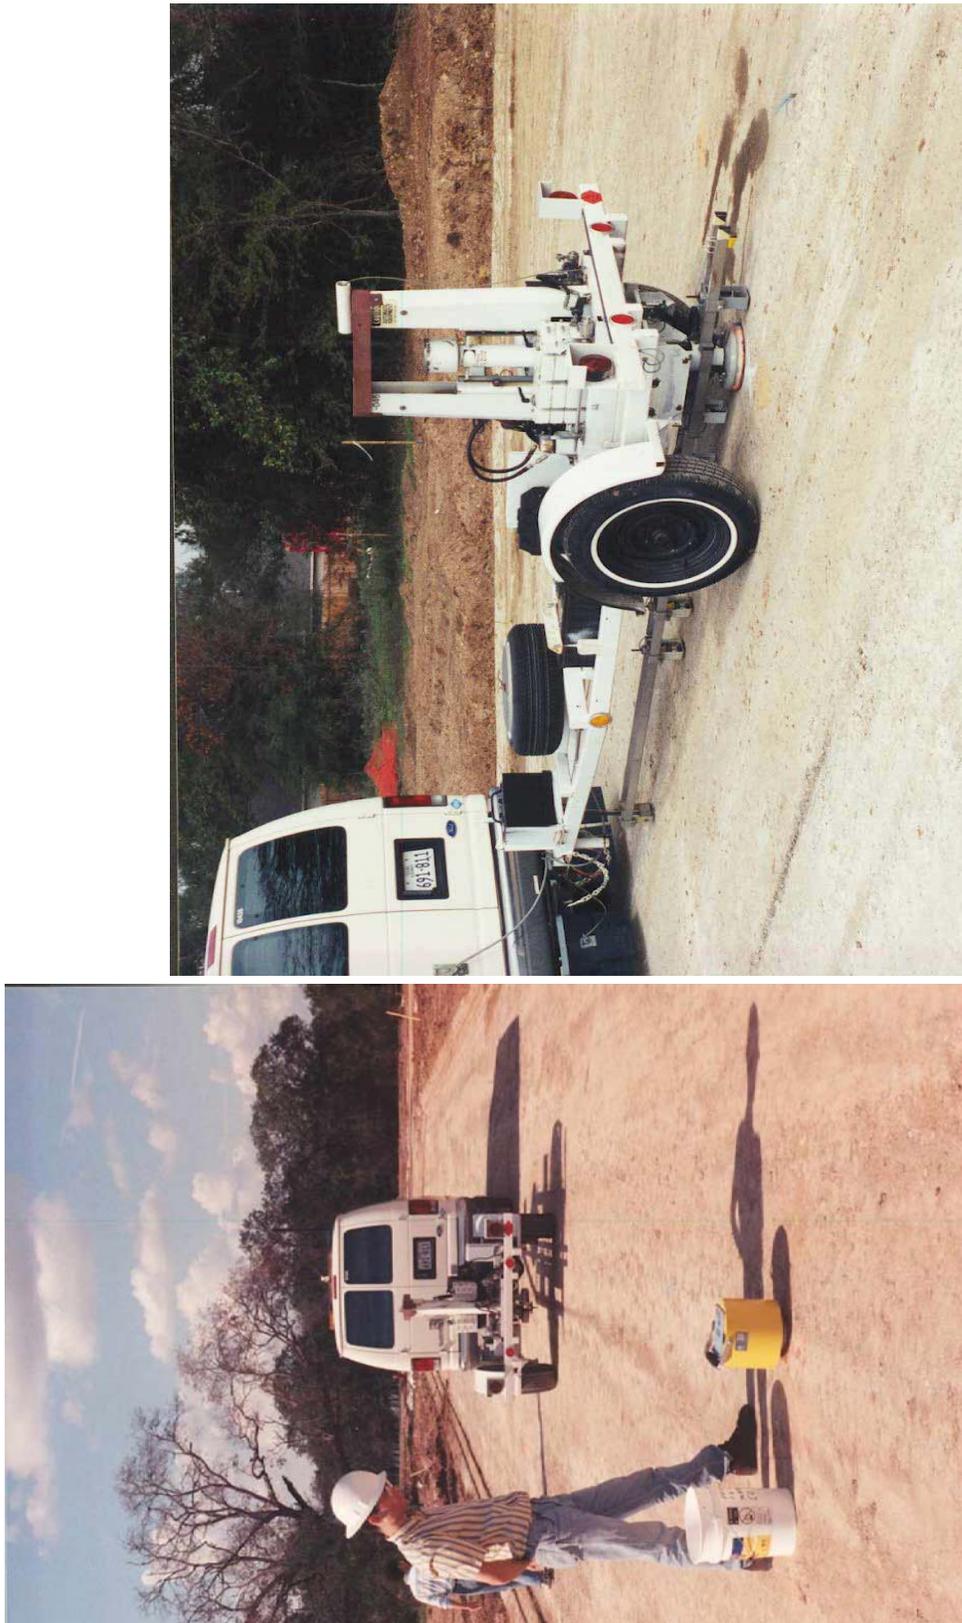
**Figure 3. Monitoring Base Stiffness.**

- Stiffness measuring techniques used in study Humboldt stiffness gage and Falling Weight Deflectometer.
- Recommended to test section every 100 ft before and after 2 passes of vibratory roller.
- Target a 40% reduction in base stiffness (as measured by the Humboldt).

To monitor the changes in base stiffness the two techniques shown in Figure 3 were used. The first is the use of a Humboldt Stiffness gauge (8). This device imparts small displacements in the base at frequencies between 100 and 200 Hz. The force versus displacement is measured to compute the soil stiffness. The second approach was to use TxDOT's Falling Weight Deflectometer (FWD). The FWD is the main structural strength testing equipment used by TxDOT. The advantage of the FWD is that it can be used to estimate the base modulus (stiffness) both during construction and after placement of the final surfacing.

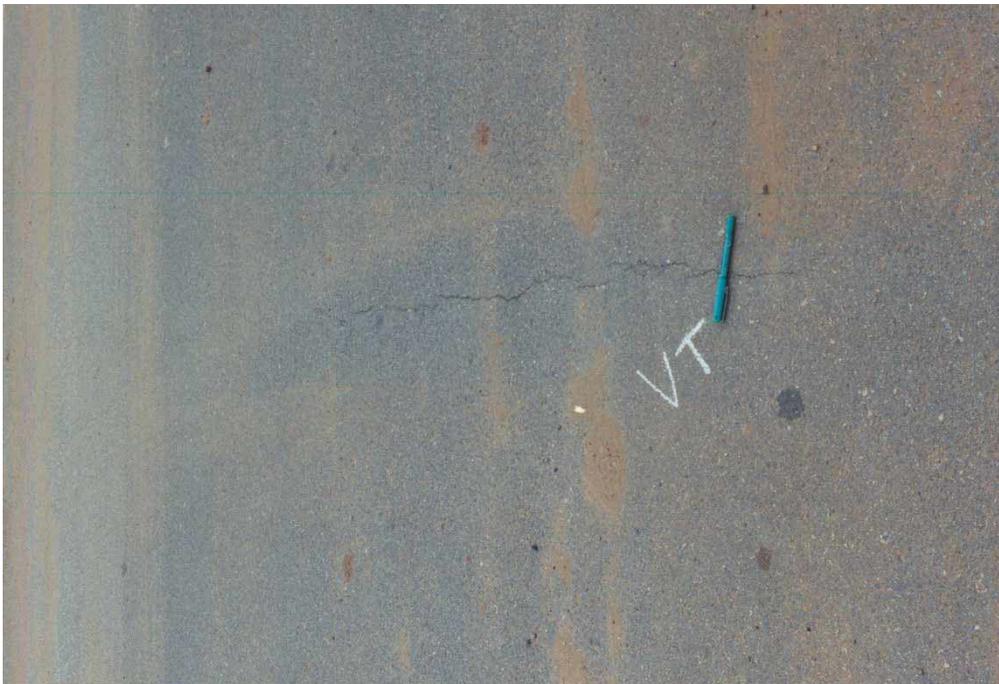
**Figure 5. 6 Month Condition Assessment. Minor Transverse Cracking in Section.**

**a) Von Trapp  
(Two cracks in 455-ft section)**

The first detailed evaluation of performance was conducted 6 months after placement of the final surfacing. During this period the sections endured both a relatively cold wet winter and construction traffic, in-particular concrete trucks. After 6 months a visual survey and a repeat FWD survey were conducted on each street. The results of the visual survey are shown in Figure 4, and typical cracks found in the sections are shown in Figure 5. The average crack length information is tabulated in Table 2.

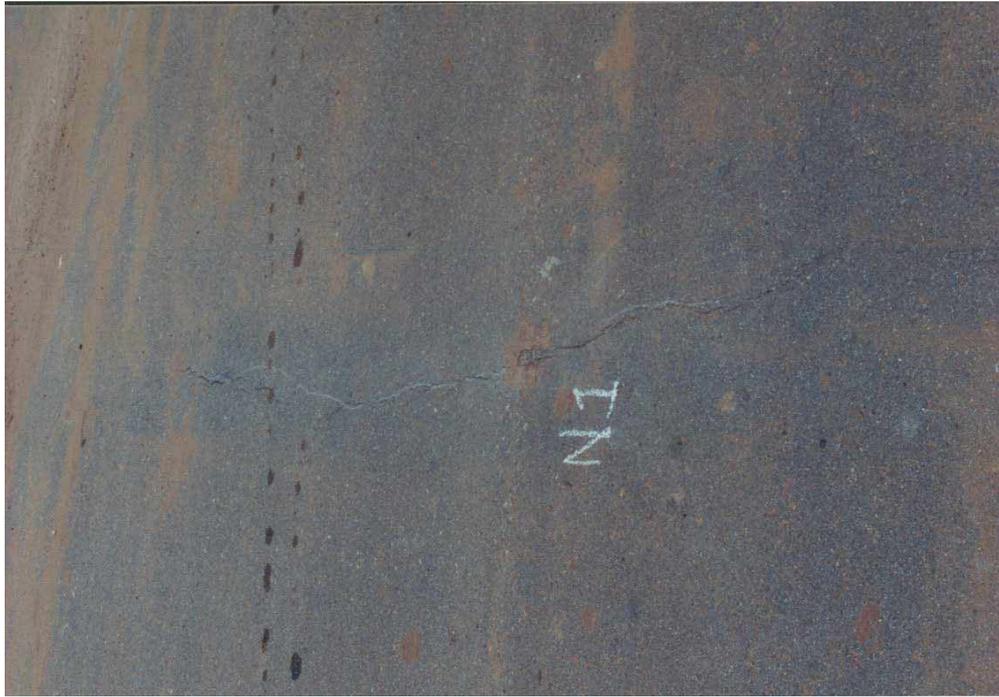
**(b) Neuburg  
(only crack in section)**
