# RCC Dam Saves City's Sole Source of Water Supply

Stephen L. Whiteside, P.E., CDM, and Fares Y. Abdo, P.E., Portland Cement Association

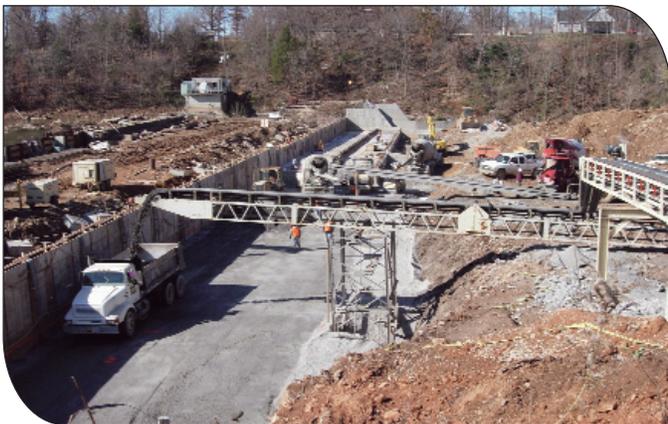
RCC conveying system

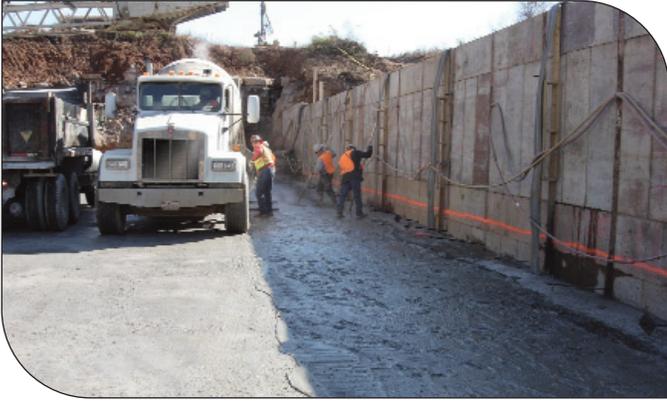
**Spreading mortar to control seepage and bond RCC lifts downstream from facing concrete**

The design included conventional concrete facing on the upstream and downstream faces. A reinforced-concrete armor cap along the crest of the dam and on the downstream portion was also included to reduce the potential for damage from large trees and other debris during overtopping events. The dam is founded on bedrock about 10 to 12 feet (3.0 to 3.7 m) below existing ground surface. An RCC apron and 6-foot (1.8-m) deep cutoff wall are located immediately downstream of the dam to reduce the potential for erosion during overtopping events. Seepage control was provided by the use of the conventional concrete facing systems, control joints with water stops spaced at approximately 15 feet (4.5 m) on center, and bedding mortar between RCC lifts for an approximate width of 10 feet (3.0 m) immediately behind the concrete facing.

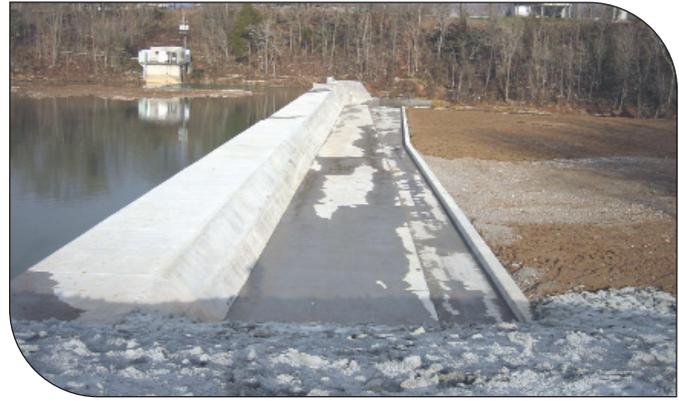
**Completed dam**

The RCC dam was designed to withstand overtopping flows during the Probable Maximum Flood, with flood depths up to 8 feet (2.4 m) above the top of the dam. The new dam is 450-feet (137.2-m) long and has a maximum height of 20 feet (6.1 m). It has a vertical upstream face. The upper portion of the downstream face is sloped at 0.8H:1V. Below the sloped portion, the dam is shaped to form a basin sloped from the right abutment to the spillway. See photo of completed dam. This basin routes water during overtopping events toward the spillway and the creek main channel.
