WATER PENETRATION TESTING OF STUCCO ON CONCRETE MASONRY CONSTRUCTION

for
Florida Concrete & Products Association
and
NCMA Education and Research Foundation

Conducted by: Masonry Information Technologists
Jim Gulde, President

Project No. 05-466B
Date: May 2007

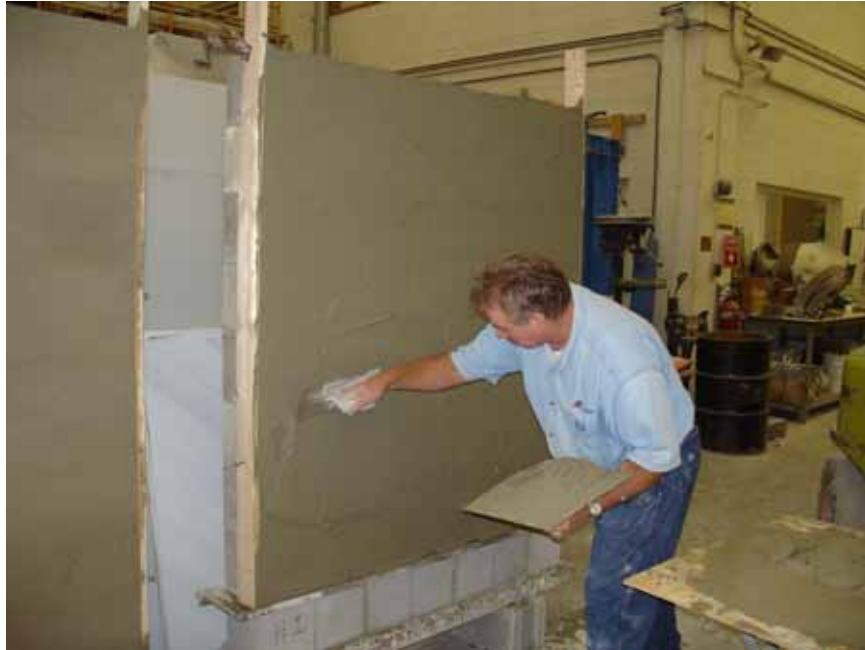
**Figure 6— The final step in the building of the walls
- the application of the stucco to the block.**

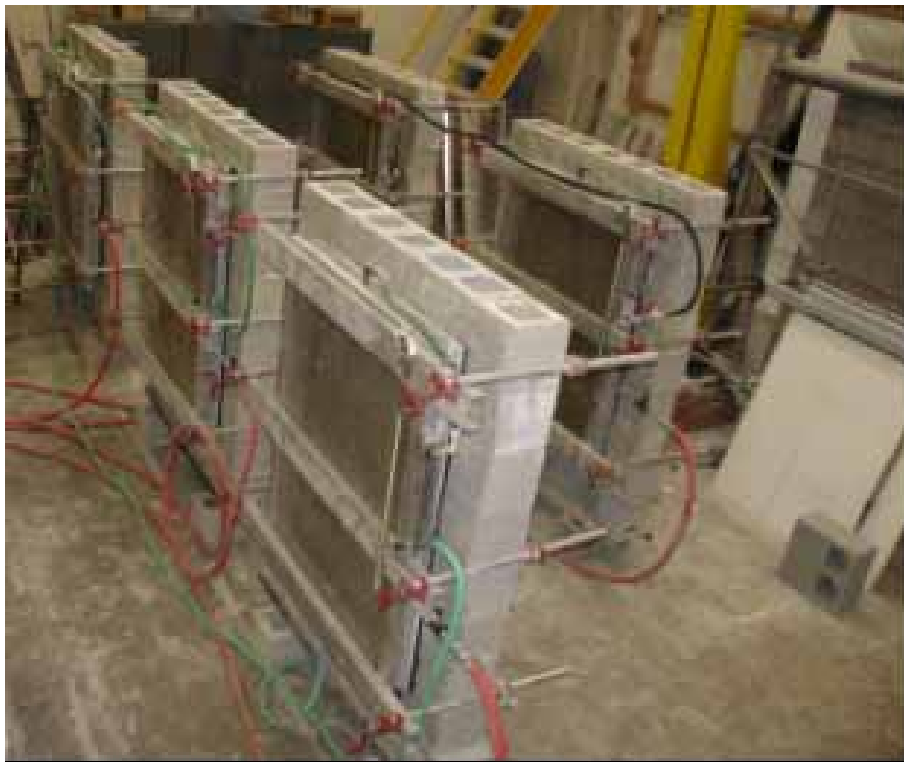
Figure 7—Phase I Test Walls
(Photo taken: December 19, 2005)

The walls in Phase I were tested at two pressures. Round one was tested at ASTM E514 prescribed water flow and pressure of 40.8 gallons per hour and 10 lbs per square foot (0.47 kPa) (2 in. (51 mm) of water) where wind velocity, V = approximately 62 mph (100 kph). Round two was tested at ASTM E514 prescribed water flow and 31 lbs per square foot (1.5 kPa) (6 in. (13 mm) of water) pressure. The higher pressure was calculated from the equation: $p = 0.00256(V)^2$ with $V = 110$ mph (177 kph) wind speed.

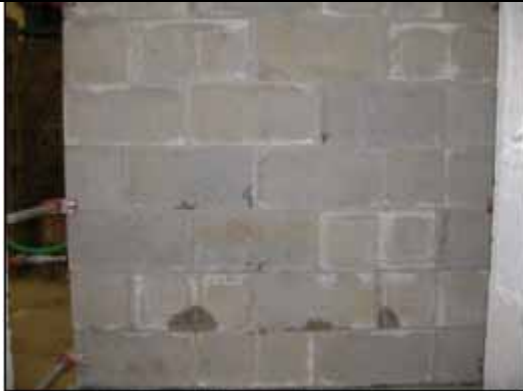
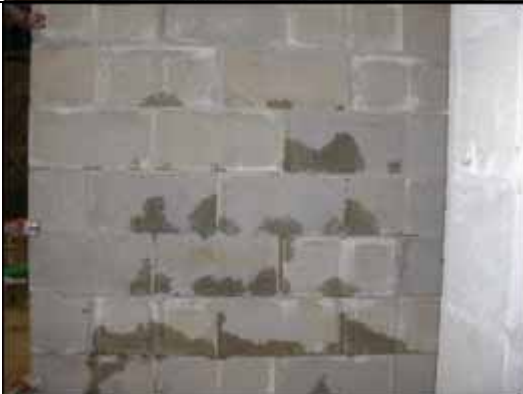
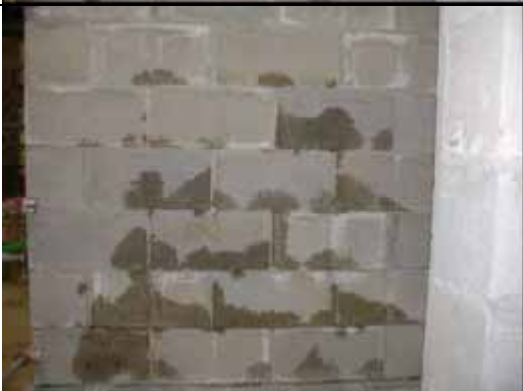
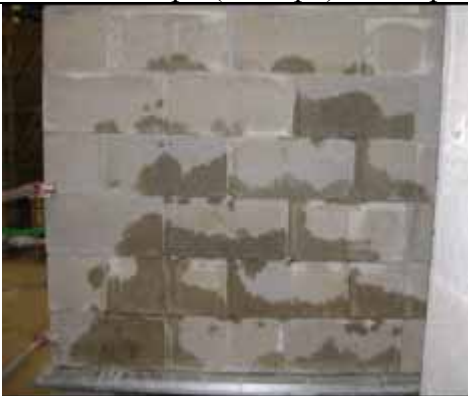
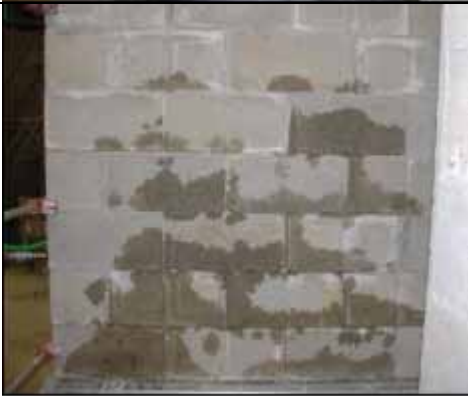
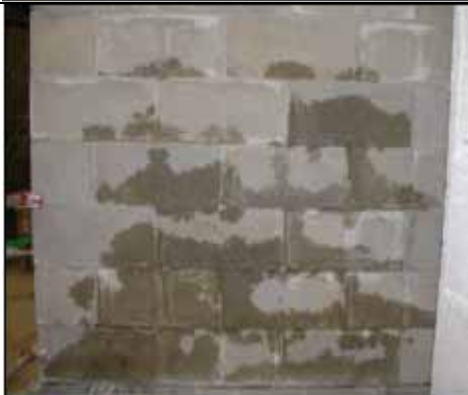
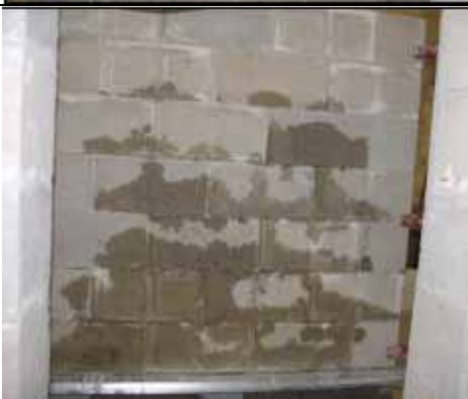
Table 3—Control Wall Performance, Phase I

Observation Time (hr)	Control wall at 62 mph (100 kph) wind speed
0.5

A photograph of a light-colored concrete masonry wall. At the bottom, there are several dark, irregular stains, indicating the beginning of water penetration. The wall is set against a dark background.
1.0

A photograph of the same wall as in the 0.5-hour image. The dark stains at the bottom have significantly increased in size and number, showing more extensive water penetration.
1.5

A photograph of the same wall. The dark stains at the bottom are even larger and more widespread, indicating further water penetration over time.

In testing the blank (control) wall, the water and pressure commensurate with the 62 mph (100 kph) wind speed were maintained for 4 hours. Visible water was observed in the wall cores and the wall face within ½ hour. In addition, approximately 20 gallons of water penetrated the wall face under pressure and approximately 0.1 gallons migrated through the wall cross section. It is estimated that water flow rates of 5 gallons per hour and 0.03 gallons per hour would be attained for the wall face and wall cross section, respectively.

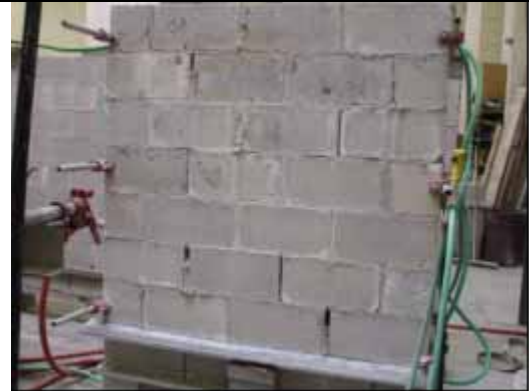
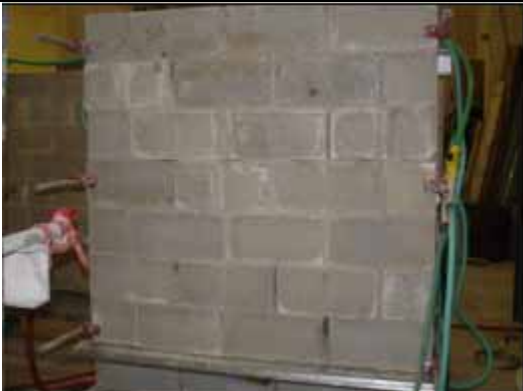
Table 4—Flawed Wall with 1/8 in. (3 mm) Skim Coat Performance, Phase I

Flawed wall with 1/8 in. (3 mm) skim coat after 4 hours at 62 mph (100 kph)	Flawed wall with 1/8 in. (3 mm) skim coat after 4 hours at 62 mph (100 kph) plus 24 hours at 110 mph (177 kph)

In testing the 5 stuccoed walls: two at 1/8 in. (3 mm) skim coat, one at 1/4 (6 mm) skim coat and two at 1/2 in. (13 mm) stucco, the water and pressure were maintained for 4 hours for the 62 (100 kph) wind speed followed by another 24 hours at 110 mph (177 kph). In both rounds of testing, no visible water was observed in any of the wall cores or on the leeward wall face.

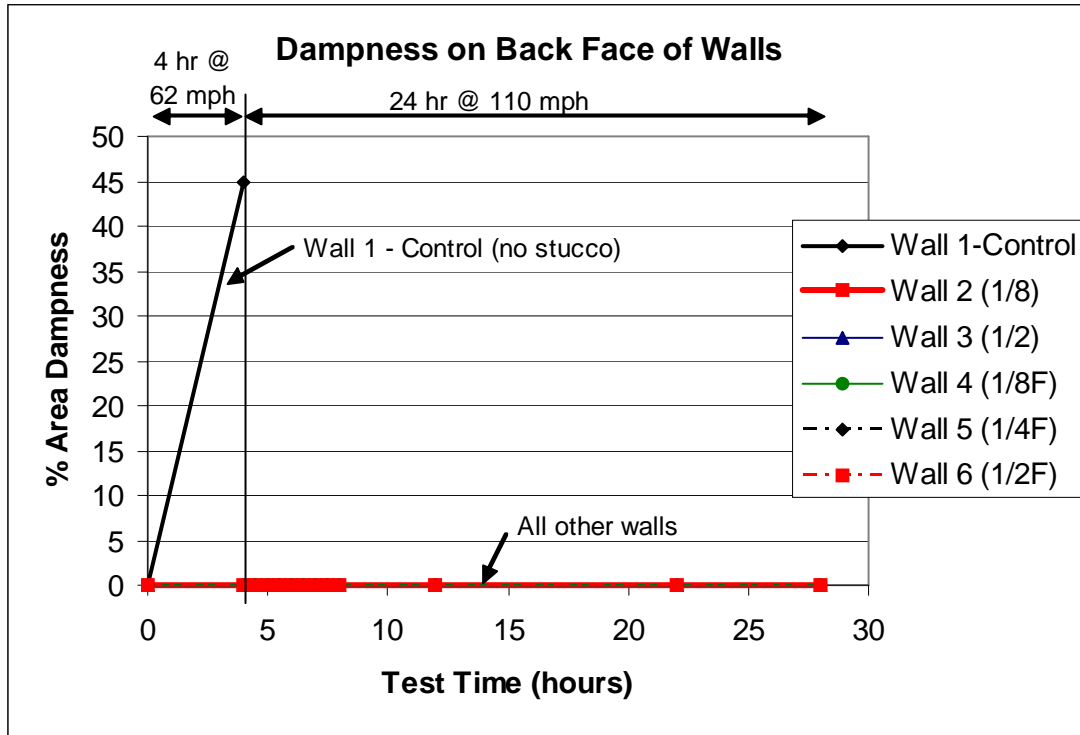
Figure 8—Area of Dampness on Leeward Wall Surface, percent

Wall Specimen	Length of Exposure, hours												
	0	4	4.5	5	5.5	6	6.5	7	7.5	8	12	22	28
Wall 1-Control	0	45	Stopped after 4 hours										
Wall 2 (1/8)	0	0	0	0	0	0	0	0	0	0	0	0	0
Wall 3 (1/2)	0	0	0	0	0	0	0	0	0	0	0	0	0
Wall 4 (1/8F)	0	0	0	0	0	0	0	0	0	0	0	0	0
Wall 5 (1/4F)	0	0	0	0	0	0	0	0	0	0	0	0	0
Wall 6 (1/2F)	0	0	0	0	0	0	0	0	0	0	0	0	0

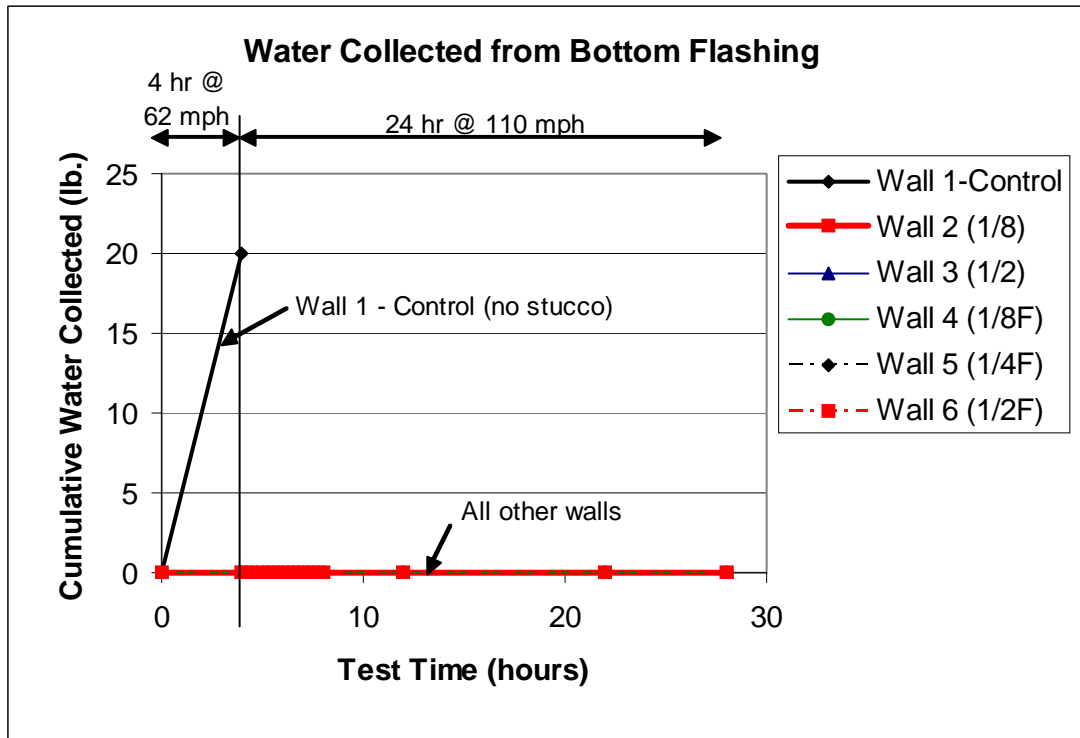
Figure 9—Test Results – Water Collected on Through-Wall Flashing, lbs.

Wall Specimen	Length of Exposure, hours												
	0	4	4.5	5	5.5	6	6.5	7	7.5	8	12	22	28
Wall 1-Control	0	20 (9.0)											
Wall 2 (1/8)	0	0	0	0	0	0	0	0	0	0	0	0	0
Wall 3 (1/2)	0	0	0	0	0	0	0	0	0	0	0	0	0
Wall 4 (1/8F)	0	0	0	0	0	0	0	0	0	0	0	0	0
Wall 5 (1/4F)	0	0	0	0	0	0	0	0	0	0	0	0	0
Wall 6 (1/2F)	0	0	0	0	0	0	0	0	0	0	0	0	0

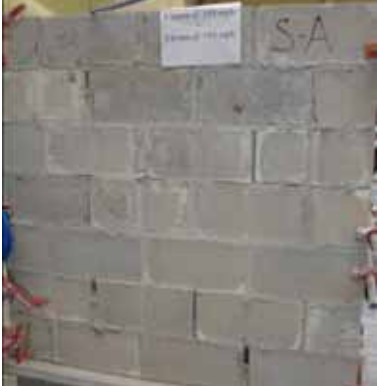
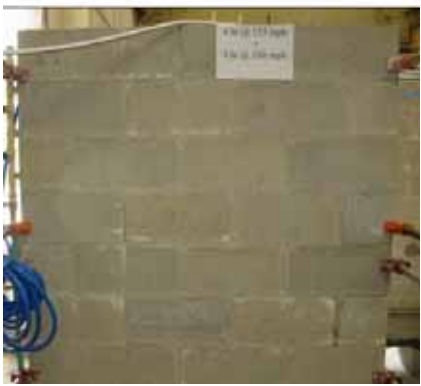
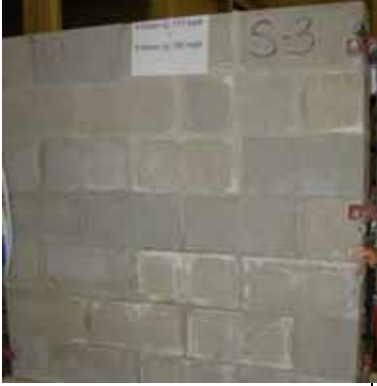
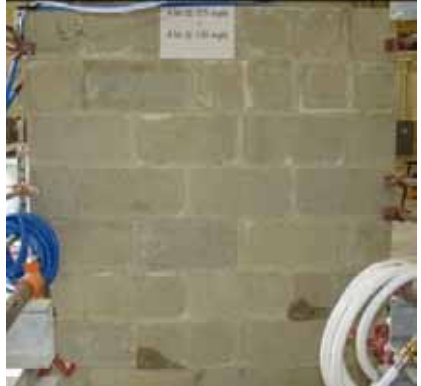
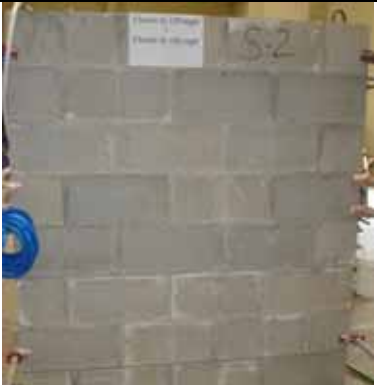
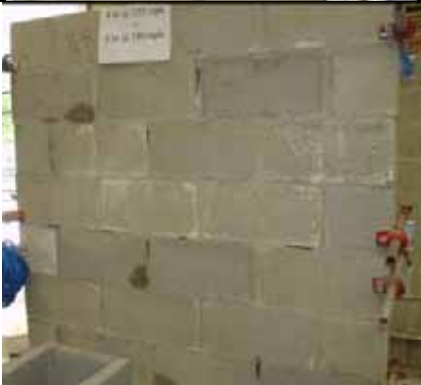
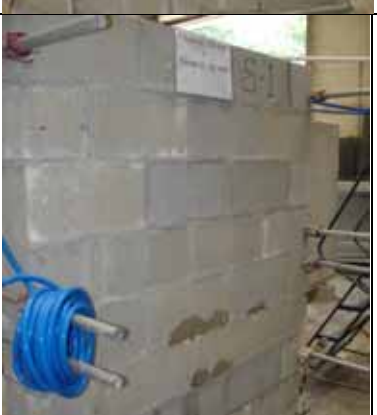
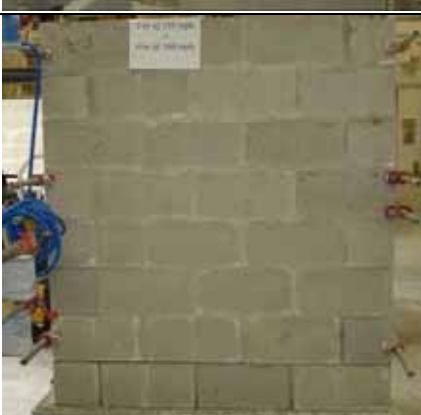
**Table 7—Walls After 4 Hours at 155 mph (249 kph)
then 4 hours at 180 mph (290 kph), Phase II,
Organized from Best to Worst Performing at Test Conclusion**

1/8 in. (3 mm) skim coat		1/2 in. (13 mm) stucco
Wall S-A Flawed Mortar Joints

After 4 hours of testing at 155 mph (249 kph) no moisture was observed in any of the cores or leakage on the leeward face in any of the test specimens. In view of this, there was little reason to continue the test to 24 hours since the object was to determine the difference in performance between walls. The pressure was then increased to that of a 180 mph (290 kph) wind. Almost immediately moisture appeared in the cores of the 1/8-in. (3 mm) coated walls. Therefore the test at 180 mph (290 kph) was continued for full 24 hours. Moisture in some form appeared on the back surface on three of the four walls. See photos in Table 5 and 6.

The 1/2 in. (13 mm) stucco walls were then tested at the same regimen as the 1/8-in. (3 mm) skim coat for comparison, i.e. 4 hrs at 155 mph (249 kph) followed by 24 hrs at 180 mph (290 kph). Again, there was no moisture observed in the first four hours at the lower wind pressure. Under the increased rate of 180 mph (290 kph), moisture was observed in the cores of these walls as well as moisture on the leeward face in some form on all four walls but in lesser overall amounts than for the 1/8-in. (3 mm) skim coat. See photos in Table 5 and 6.

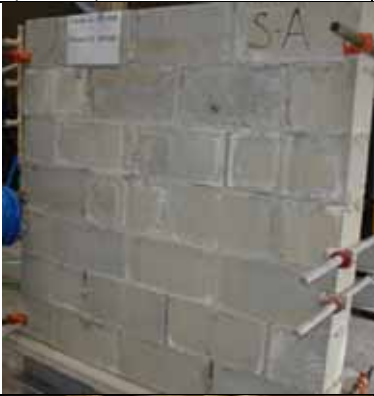
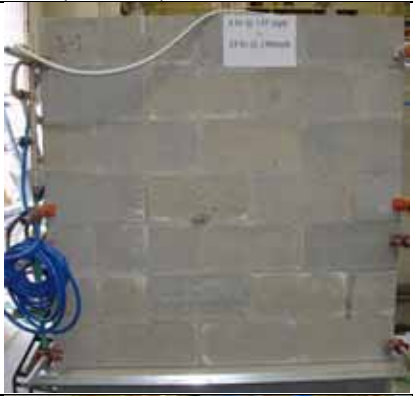
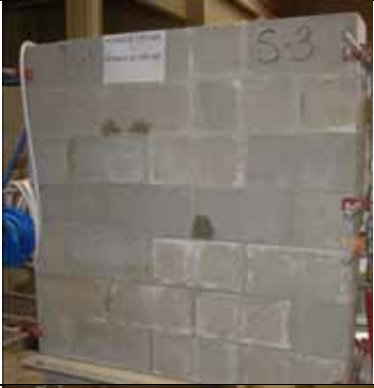
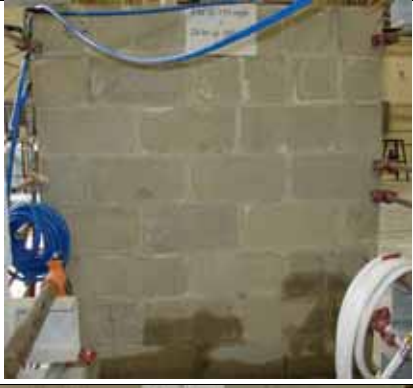
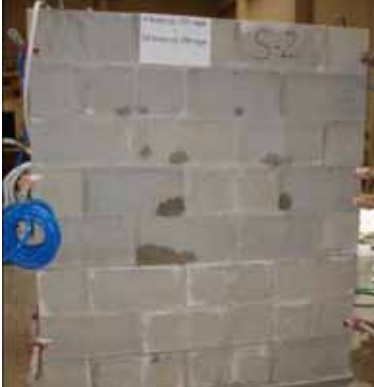
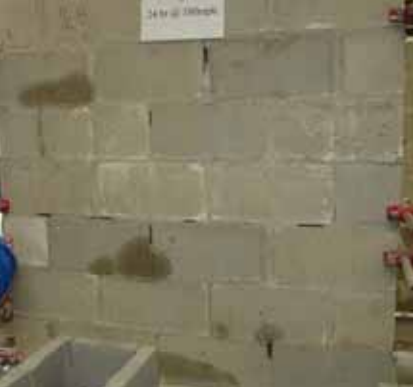
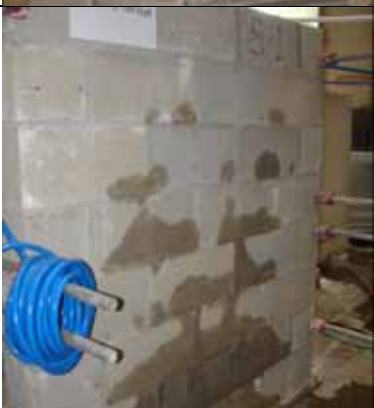
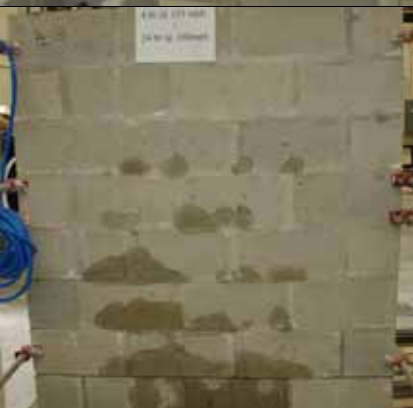
**Table 8—Walls After 4 Hours at 155 mph (249 kph)
then 24 hours at 180 mph (290 kph), Phase II,
Organized from Best to Worst Performing at Test Conclusion**

1/8 in. (3 mm) skim coat		1/2 in. (13 mm) stucco	
Wall S-A Flawed Mortar Joints

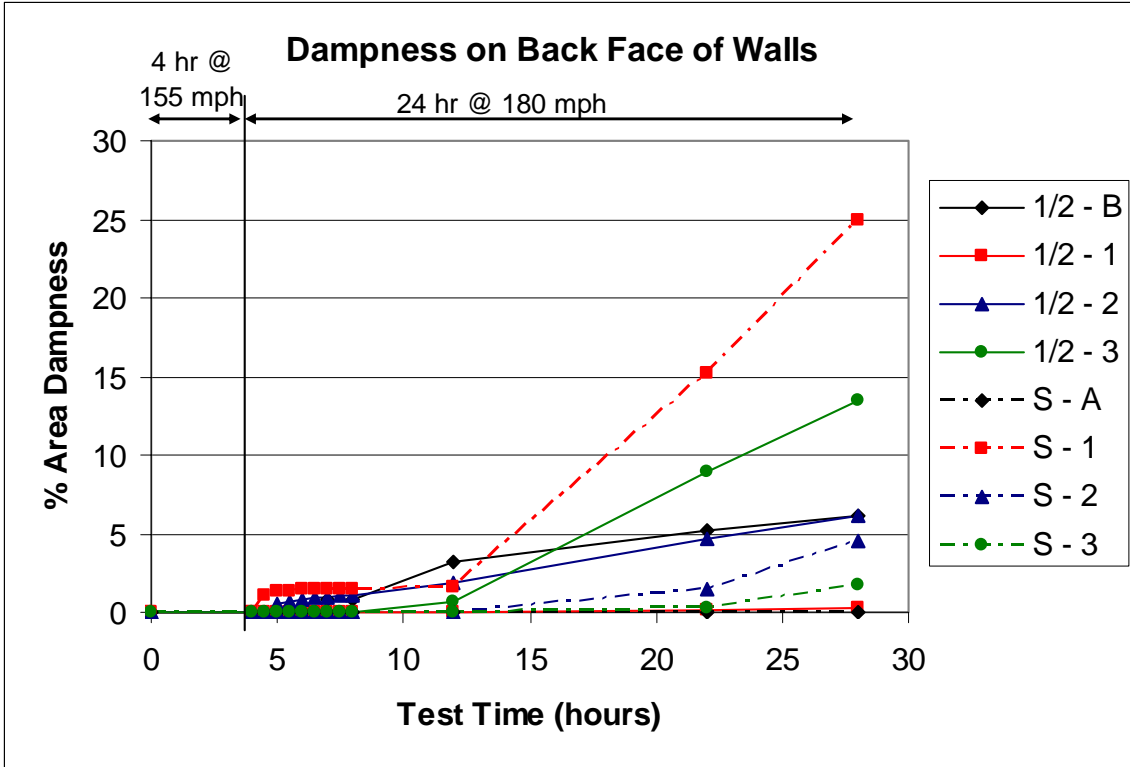
Figure 10—Area of Dampness on Leeward Wall Surface, percent

Wall Specimen	Length of Exposure, hours													
	0	4	4.5	5	5.5	6	6.5	7	7.5	8	12	22	28	
½ - B	0	0	0	0	0	0.2	0.5	0.8	0.8	0.8	3.2	5.2	6.1	
½ - 1	0	0	0	0	0	0	0	0	0	0	0	0.2	0.3	
½ - 2	0	0	0	0.6	0.7	0.8	0.9	1	1.05	1.1	1.9	4.7	6.1	
½ - 3	0	0	0	0	0	0	0	0	0	0	0.7	8.9	13.5	
S - A	0	0	0	0	0	0	0	0	0	0	0	0	0	
S - 1	0	0	1.1	1.3	1.3	1.5	1.5	1.5	1.5	1.5	1.6	15.2	24.9	
S - 2	0	0	0	0	0	0	0	0	0	0	0	1.5	4.5	
S - 3	0	0	0	0	0	0	0	0	0	0	0	0.3	1.8
