PROJECT PROFILE McKinney Lake Dam

AN RCC FIRST IN NORTH CAROLINA

The first dam remediation project in North Carolina to use roller compacted concrete (RCC) for overtopping protection.

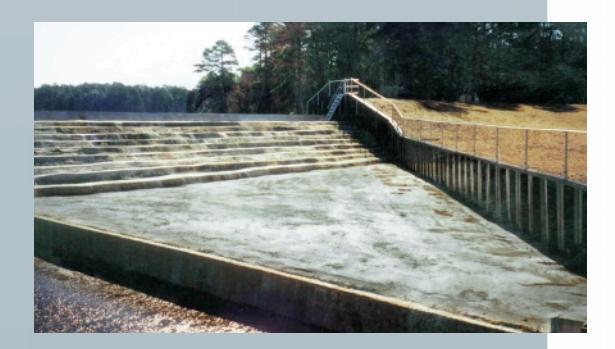
Originally constructed in the late 1930s as a Works Progress Administration project, the 23-ft-high (7 m) dam consists of an earthfill embankment with a concrete corewall. The principal spillway is located in the middle third of the dam and consists of a concrete gravity overflow section and a rectangular concrete outlet channel. An unlined emergency spillway was cut into the left third of the embankment.

When state officials determined that the dam suffered from safety deficiencies, roller-compacted concrete (RCC) was chosen as the material of choice for improvements. Plans called for increasing spillway capacity and raising the top of the dam. McKinney Lake Dam is located on Hitchcock Creek, north of Rockingham, North Carolina. Situated upstream of the McKinney Lake National Fish Hatchery, the dam's primary purpose is to supply water to the facility.

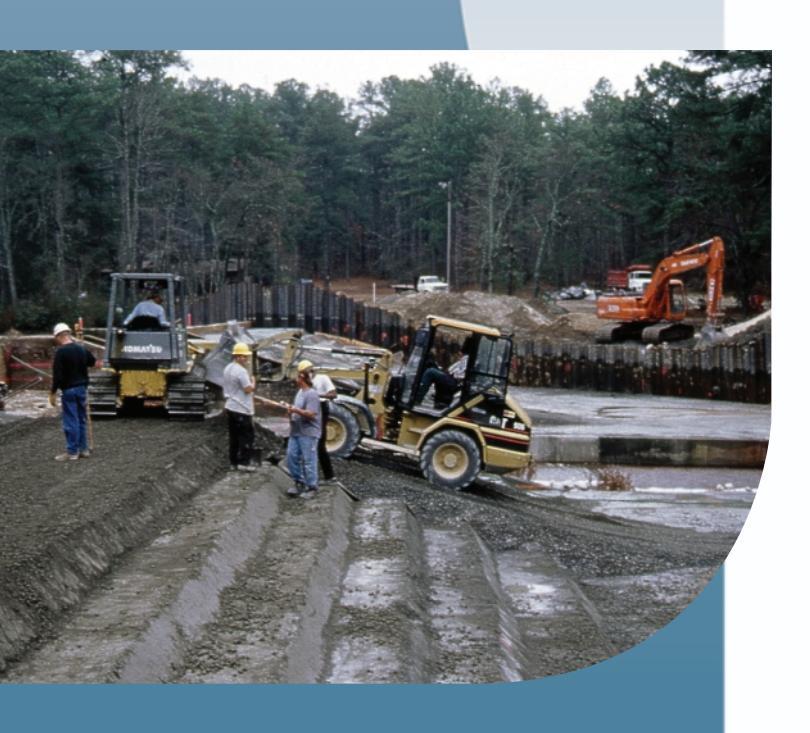
REMEDIATED STRUCTURAL FEATURES

> The project's design concept addressed inadequate spillway capacity by armoring a section of the embankment with RCC, and raising the crest of the embankment to contain the 1/3 PMP flood level plus freeboard. The armored section of the embankment serves as the emergency spillway.

The 1600 yd³ (1223 m³) of RCC armoring was placed on the upper portion of the upstream slope, the crest, the downstream slope, and an apron area beyond the downstream slope. Sheet piling driven along the edges of the RCC serves as spillway training walls to contain the design discharge. The training walls converge to direct outflows up to the projected 100-year flood level through an existing box culvert under the downstream access road. The end result: improvements with RCC increased the spillway discharge capacity to more than 11,000 cfs (311 cms),
