WATER RESOURCES

Aesthetics Play Key Role in Dam Rehabilitation

A rapidly growing metropolitan county depends on RCC to rehabilitate an aging dam and restore the focal point of a prominent park.

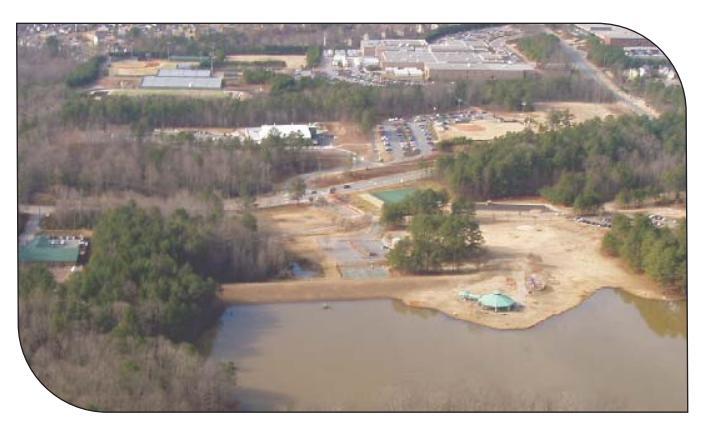
Aerial view of the Y-17 dam and downstream reach prior to rehabilitation.

The Y-17 structure consists of an earthen embankment dam approximately 30 ft (9.1 m) high and 900 ft (274 m) long. Studies of the Y-17 structure determined that the existing 200 feet (61 m) wide vegetated earthen spillway was inadequate for the design flows. An options assessment determined that the most cost effective solution was to armor the entire downstream slope and abutments of the dam with roller-compacted concrete (RCC).

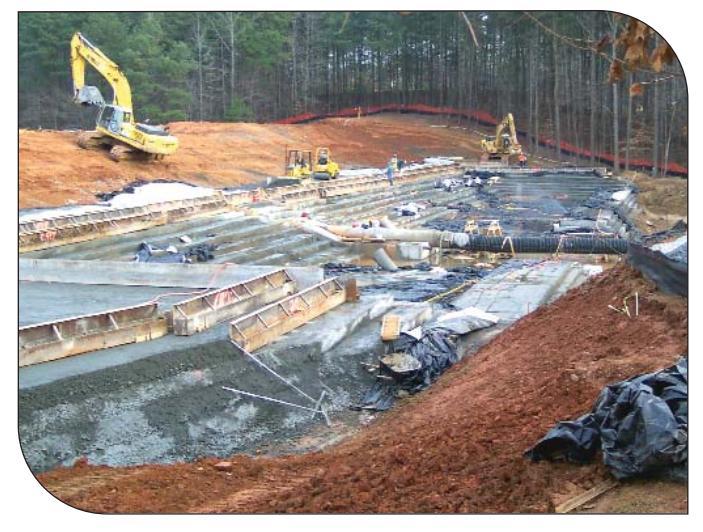
Completion of the RCC stilling basin and construction of the RCC spillway steps and sidewalls.

Early in construction, thick deposits of alluvial soils with high liquid limits and very low shear strength were identified along the downstream toe of the existing embankment. This discovery necessitated the removal of more than 8,000 yd³ (6,116 m³) of additional soil. A re-design of the RCC spillway stilling basin was carried out after removal of the unsuitable material to correspond with the newly excavated site topography. The re-design resulted in an additional 900 yd³ (688 m³) of RCC. RCC placement began in mid December 2004 and was completed in early February 2005.

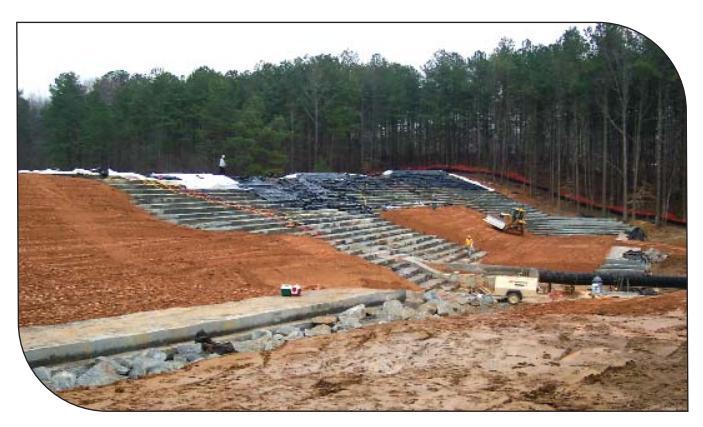
Placement of earthfill over the completed RCC spillway.

spillway were covered with earthfill and vegetated to hide the RCC. The crest and crest sidewalls are still exposed. The spillway activates for storms at or less than a 25 year frequency. As a result, earthfill covering the RCC may erode during these storms requiring some future maintenance.

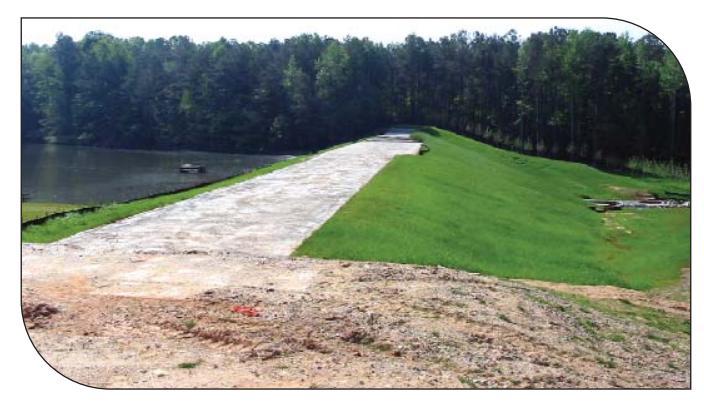
Completed project with grass covered downstream slope.

The completed RCC spillway safely routes approximately 18,950 cfs (537 m³/sec.) through the Y-17 watershed during the PMP design storm. Since the structure is located in a prominent park, the downstream slopes of the RCC
